Safety Information Bulletin

SIB No.: 2018-04R2

Subject: Environmentally Assisted Cracking in certain Aluminium Alloys

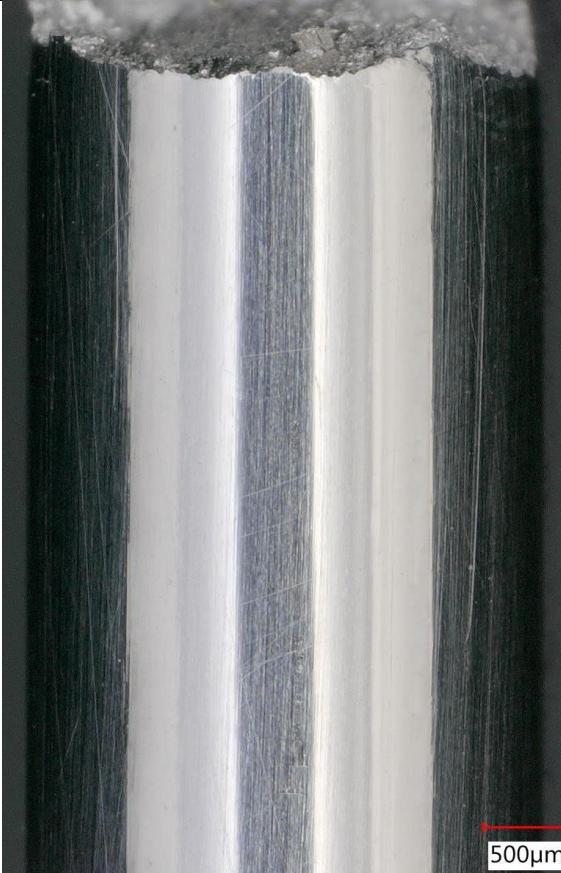
- A material is considered to have failed the test, and susceptible to EAC, if it shows cracking along the grain boundaries without corrosion attack or oxidation products on sample or fracture surface, as shown on the figures 1, 3 and 5 below.
- If obvious that cracking has not occurred, a check for the presence of grain boundary cracking can be made by optical examination with magnification of at least 50x. Presence of grain boundary cracking is also considered a test failure.
- Specimen and fracture surface have to meet the validity requirements as given in Table 1 of this SIB. If the requirements are not met, the test is invalid and should be repeated.

Figure 1 – Round smooth bar: not corroded

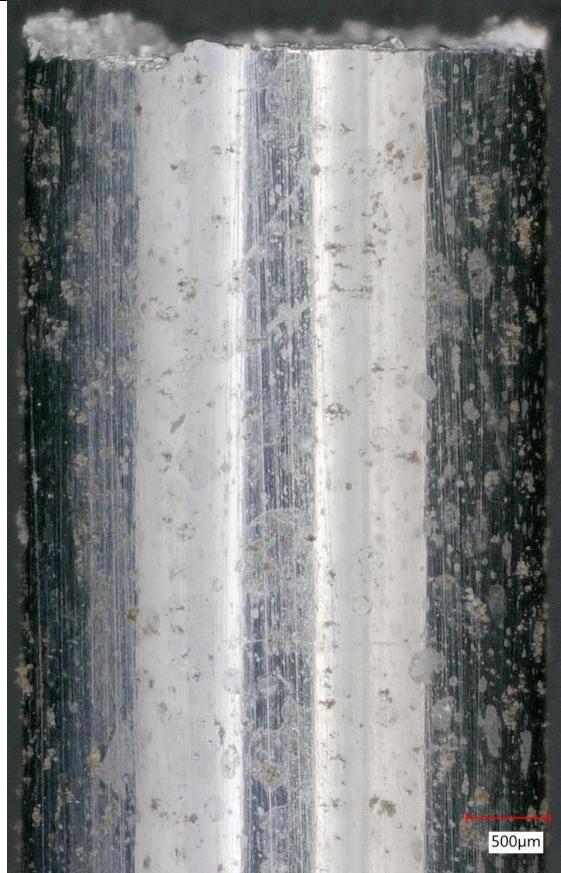
Observation	Requirement for a valid test
Evidence of the presence of condensation on specimen surfaces	Not allowed
Corrosion pitting or corrosion products on specimen surfaces (figures 2, 4 and 6)	Not allowed Surface of a failed sample by light microscopy, level of magnification: 50x Fracture surface and rim of fracture surface by Scanning Electron Microscopy, level of magnification: 2000x
Fracture surface morphology in the case of through fracture	Predominantly intergranular fracture path with little or no evidence of ductile decohesion (see figure 5) Level of magnification for examination by Scanning Electron Microscope: 6000x

Figure 2 – Round smooth bar: corroded

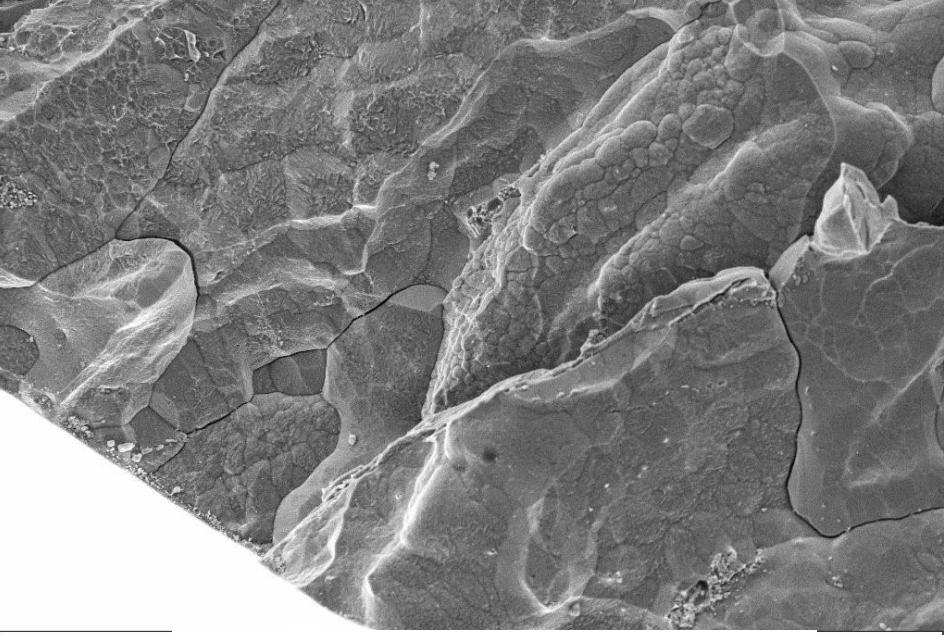
<p data-bbox="145 849 1089 928">20 μm</p> <p data-bbox="325 873 887 897">Only precipitates on the grain boundaries are visible</p> <p data-bbox="280 944 954 976">Figure 3 – Fracture surface without traces of corrosion</p>

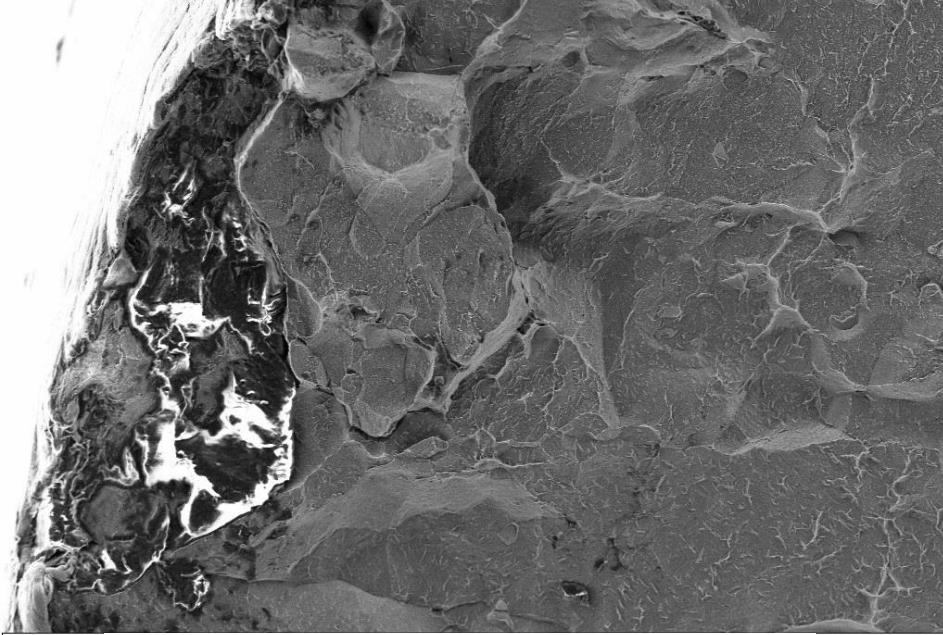
<p data-bbox="1134 849 2077 928">10 μm</p> <p data-bbox="1268 873 1920 897">Precipitates & dark oxides on the grain boundaries are visible</p> <p data-bbox="1291 944 1920 976">Figure 4 – Fracture surface with traces of corrosion</p>

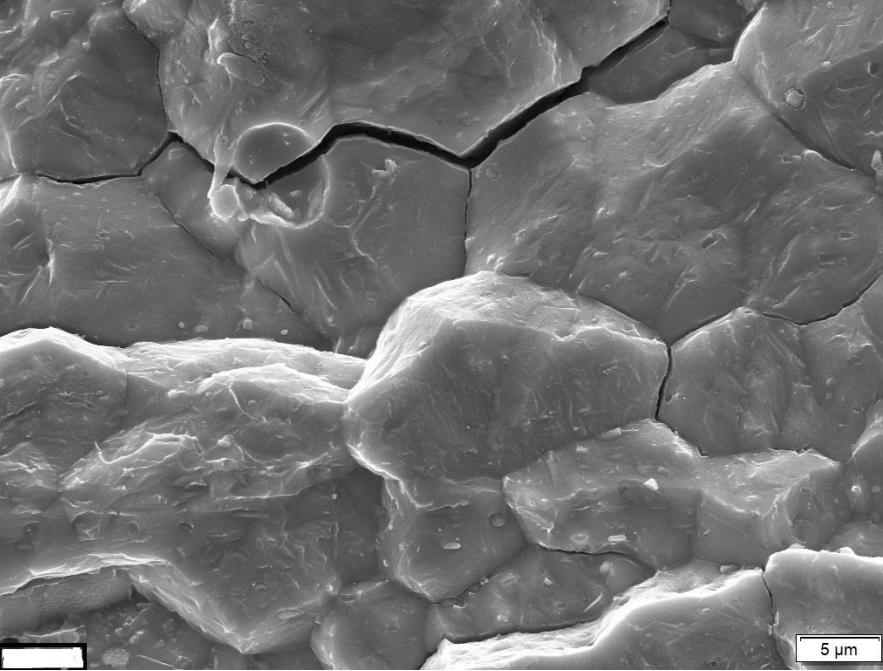
Note 1: The subject of this SIB is EAC caused by hydrogen assisted embrittlement resulting in a decrease of toughness but in absence of an obvious corrosion reaction (see Appendix 1 of this SIB, Figure 5). It is different from classical stress corrosion cracking characterised by anodic dissolution

<p data-bbox="361 949 833 981">Figure 5 – Typical EAC fracture surface</p>

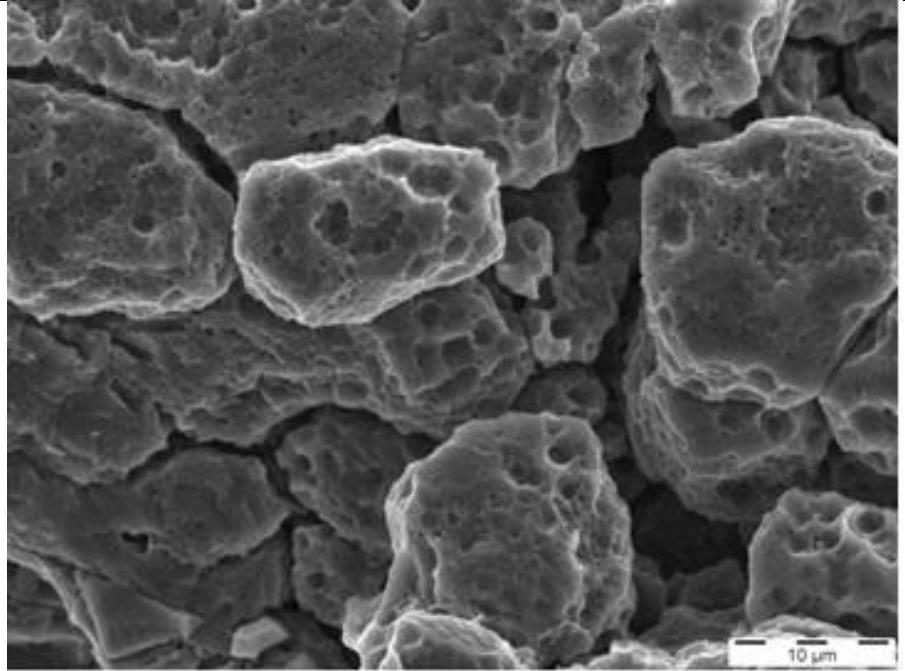
with loss of material accompanied with findings of active corrosion like pitting or attack of grain boundaries (see Appendix 1 of this SIB, Figure 6).

<p data-bbox="1343 949 1814 981">Figure 6 – Typical SCC fracture surface</p>
